GENERAL INFOR						\$ 6 6 5 14 2 4 5	2.90				
TYPE OF INSPECTION: ☑ CAFO ☐ COMPLAINT ☐ RECONNAISSANCE ☐ ERU FOLLOW UP ☐ OPERATOR REQUEST ☑ OTHER											
FACILITY NAME (LLC, Inc., Corp, Partnership, sole proprietorship, etc.) Forrest Farms #2 - Sunny Meadow						•	INSPECTION DATE Jan. 29, 2013			L TIME O AM	
ADDRESS N. 100 N. Road								ONGITUDE (Decimal) N -88.276			TURE TIME 40 AM
CITY Strawn	STATE IL	ZIP COD 61775		INSPECTOR(s) E. Ackerman & S. Loftus			ACCOMPANIED BY (if a Matti Shalev			icable)	
COUNTY Livingston	1 1		1	OLITICAL TOWNSHIP Sermanville			~50 F Wet			ION TYPE er	
Facility Owner(s): Exemption 6 and Exemption 7(C)	NAME Matti Shale	CONTACTED PHONE alev-Forrest Farms, Inc. YES NO NO						MO	BILE		
	ADDRESS				CITY			STATE	710	CODE	
	Exemp	tion 6	and	Exe	emption	· 7(C	3)				
	NAME				. , ,					MOBILE	
	ADDRESS				CITY			STATE	ZIP	CODE	
Facility Operator(s):	NAME				CITY NO			PHONE		MOBILE

Facility Name: Forrest Farms #2 - Sunny Meadow Inspection Date: Jan. 29, 2013 Page 2/8

IEPA - DIVISION OF WATER POLLUTION CONTROL DIGITAL PHOTO REPORT

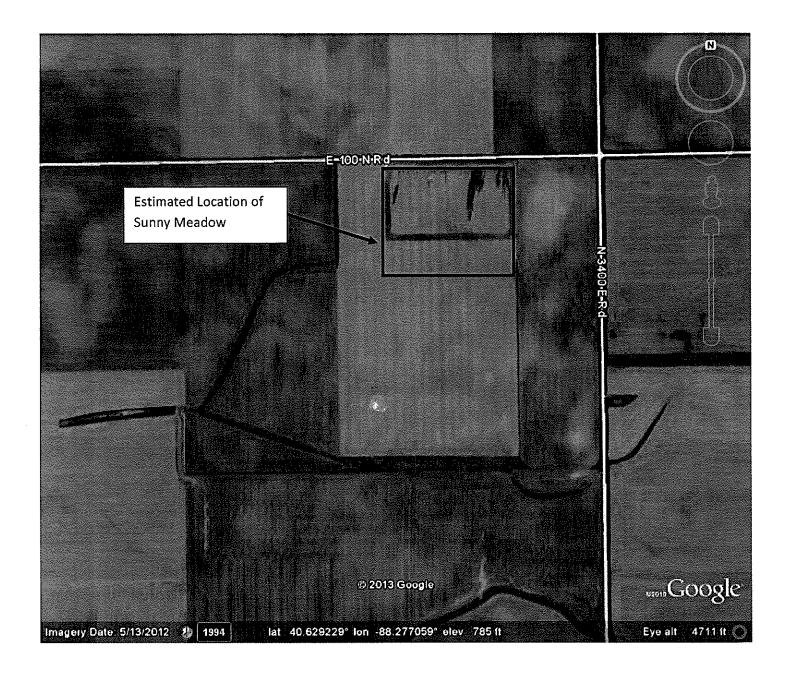
Figure 2. Plan View From Google Earth of Estimated Location of Sunny Meadow near

Strawn in Livingston County on January 29, 2013.

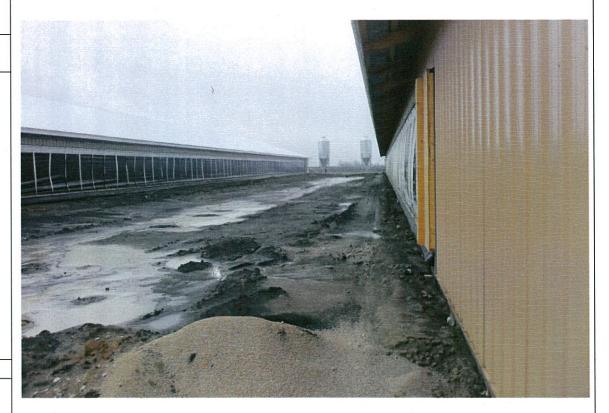
Photo #: 2

Area between two newly constructed total confinement buildings. This area drains to the south. View is south.

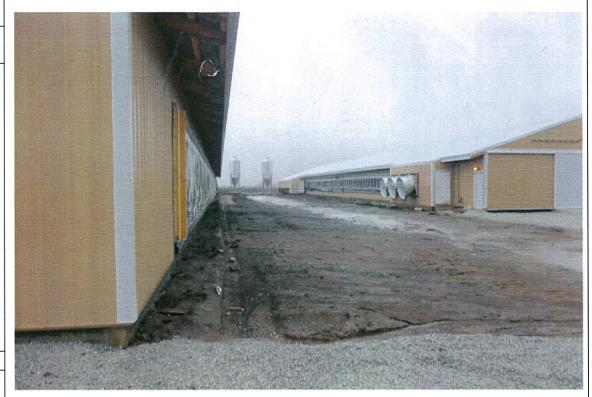
Photo #: 3

Another area between two newly constructed total confinement buildings. This area drains to the south. View is south.
